## **Technical Resources Bulletin**

Subject: STRI Wind Uplift Testing

ANSI/SPRI/FM 4435 ES-1-2017 Test Standard for Edge Systems Used With Low Slope Roofing

#### **ANSI/SPRI ES-1 PERFORMANCE TEST REPORT**

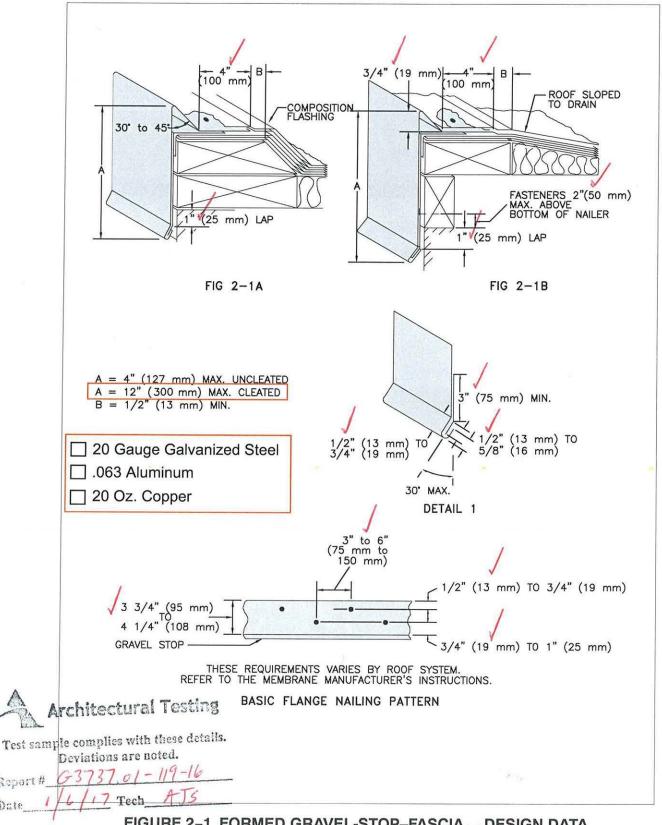
FIGURE 2-1 FORMED GRAVEL-STOP-FASCIA — DESIGN DATA

Nominal 10 ft long sections of 5-1/2 in wide by 12 in high by 0.033 in thick galvanized steel, 0.060 in thick aluminum or 0.023 in thick copper flashing were attached to roof edge mock-ups constructed of S-P-F dimension lumber using 11-1/4 in wide by 3-1/2 in high by 0.033 in thick galvanized steel, 0.060 in thick aluminum or 0.023 in thick copper continuous cleats respectively. Prior to assembly, the front face of the flashing was drilled and fitted with ten 5/16 in eyebolts, weld nuts (with barrel) and two hex nuts and washer (outside only), six in from each end and twelve in on center, on the longitudinal centerline. The front face of the cleat was nailed to the edge of the S-P-F member with a single row of ten 1-3/4 in x 0.155 in ring shank roofing nails, 2 in from each end, 10 in on center (first space) and 12 in on center (typical). The flashing was then hooked onto the front bend of the cleat and its top face was nailed to the top of the S-P-F member with two staggered rows of 1-3/4 in x 0.155 in ring shank roofing nails 3 in / 6 in from each end and 6 in on center.

See Photographs in Appendix A and Drawings in Appendix B for additional details.

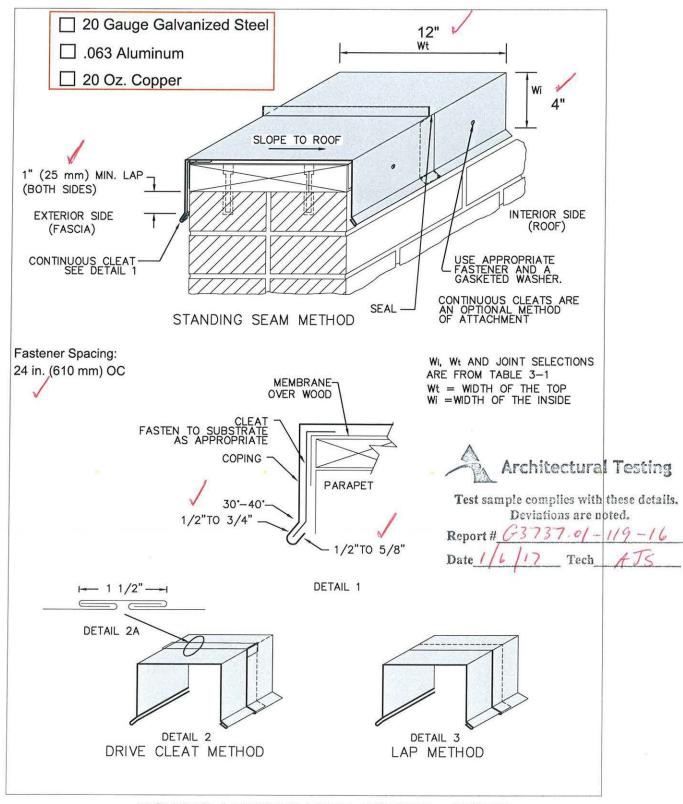
FIGURE 3-1 FORMED METAL COPINGS — DESIGN DATA

Nominal 10 ft long sections of 12 in wide top face by 4-3/4 in high front and back face by 0.033 in thick galvanized steel, 0.060 in thick aluminum or 0.023 in thick copper coping were attached to roof edge mock-ups constructed of S-P-F dimension lumber using 2 in wide by 4-1/2 in high by 0.033 in thick galvanized steel, 0.060 in thick aluminum or 0.023 in thick copper continuous cleats respectively. Prior to assembly, the top and front faces of the coping were drilled and each fitted with ten 5/16 in eyebolts, weld nuts (with barrel) and two hex nuts and washer (outside only), 6 in from each end and 12 in on center, on the longitudinal centerlines. The front face of the cleat was nailed to the face of the S-P-F member with a single row of six 1-3/4 in x 0.155 in ring shank roofing nails 2 in from each end, 22 in on center (first space) and 24 in on center (typical). The coping was then hooked onto the front bend of the cleat, wrapped over the top of the mock-up, and its back face was fastened to the edge of the S-P-F member with a single row of six, #12-14 by 1-1/2 in, self-drilling, hex-head, coated carbon steel screws, 2 in from each end, 22 in on center (first space) and 24 in on center (typical).

See Photographs in Appendix A and Drawings in Appendix B for additional details.

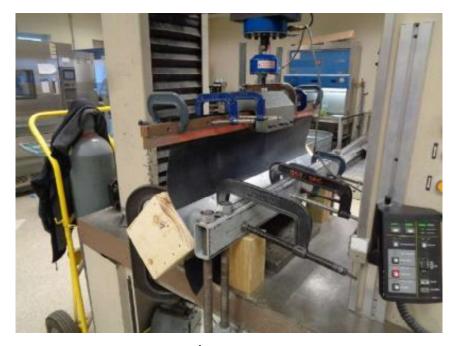
Photo No. 1
ANSI/SPRI Test RE-1 Test Set-up

Nominal 36 in wide sections of 0.035 in thick galvanized steel fascia were attached to a standard S-P-F roof edge mock-up utilizing a 0.042 in thick reinforced TPO roofing membrane. The 36 in fascia sections were cut to include eleven pre-punched holes for fasteners. All fasteners were 1-3/4 in x 0.155 in ring shank roofing nails. The loose end of the roofing membrane was fixed to the crosshead of a SATEC Unidrive, Model MII 50UD Universal Test Machine (ICN: Y002011) and pulled at an approximate 45° angle from the restrained gravel stop assembly at a speed of 0.25 in per minute. Load was applied until specimen failure, and load began to drop. See Photographs in Appendix A.

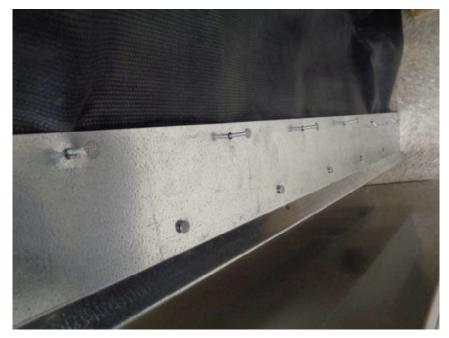
Photo No. 2
ANSI/SPRI Test RE-1 Typical Mode of Failure

Mode of failure for all specimens was nails began withdrawing from the wood

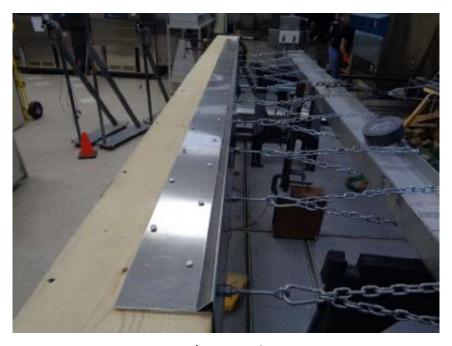
Photo No. 3
ANSI/SPRI Test RE-2, Test Setup

Load was applied to the ten eye bolts using equal-length chains, a spreader beam, steel cable and an electric winch. Applied load was measured with an in-line 2000 pound load cell. Center-point deflection of the flashing face was measured with an electronic linear displacement transducer. Load was applied incrementally and held ("Sustained") for a minimum of 60 seconds with intermediate load relaxation periods for specimen deflection to stabilize.

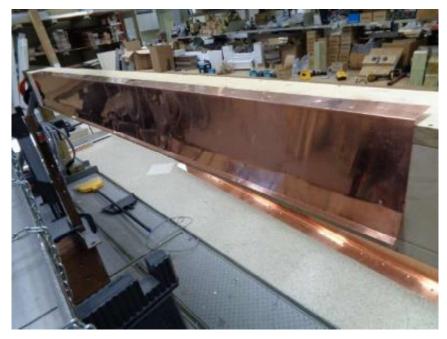
Photo No. 4
ANSI/SPRI Test RE-2, Failure of Copper Cleat, Bent to Release Fascia

Mode of failure for steel and aluminum specimens was cleat nails withdrawing from the wood, and for the copper specimens the cleat bent releasing the fascia. See Photographs in Appendix A for test set-up.

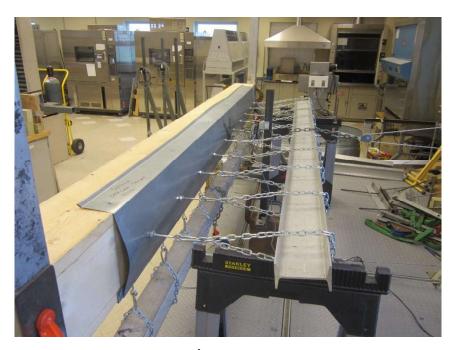
Photo No. 5
ANSI/SPRI Test RE-3, Coping Pull-Off Test In Progress; Tested with Face Down

Load was applied to the ten eye bolts of the coping top surface using equal-length chains, a spreader beam, steel cable and an electric winch. Applied load was measured with an in-line 2000 pound load cell. Center-point deflection of the coping face was measured with an electronic linear displacement transducer. Load was applied to the ten eye bolts of the coping face surface, secured with cleat, using equal-length chains, a spreader beam, steel cable and an electric winch. Applied load was measured with an in-line 2000 pound load cell. The two loads were applied simultaneously, proportionally and incrementally and held ("Sustained") for a minimum of 60 seconds with intermediate load relaxation periods for specimen deflection to stabilize.

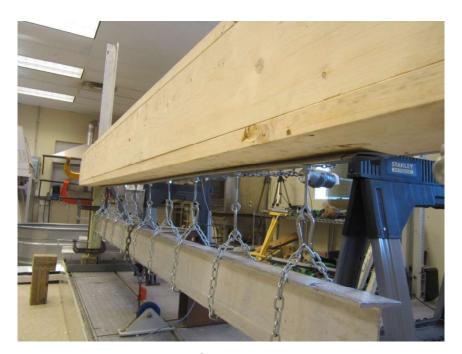
Photo No. 6
ANSI/SPRI Test RE-3, Coping Pull-Off Test In Progress
Face Loading Shown under Load

Testing of the steel and aluminum coping members was stopped prior to specimen failure due to test fixture limitations. Mode of failure for the copper specimens was coping deformation under load and subsequent disengagement from the lower lip of the cleat as load was relaxed. See Photographs in Appendix A for test set-up.
